# Debris/Ice/TPS Assessment And Photographic Analysis For Shuttle Mission STS-48

**Gregory N. Katnik**  
NASA/Kennedy Space Center

DEBRIS/ICE/TPS ASSESSMENT  
AND  
PHOTOGRAPHIC ANALYSIS  
OF  
SHUTTLE MISSION STS-48

September 12, 1991

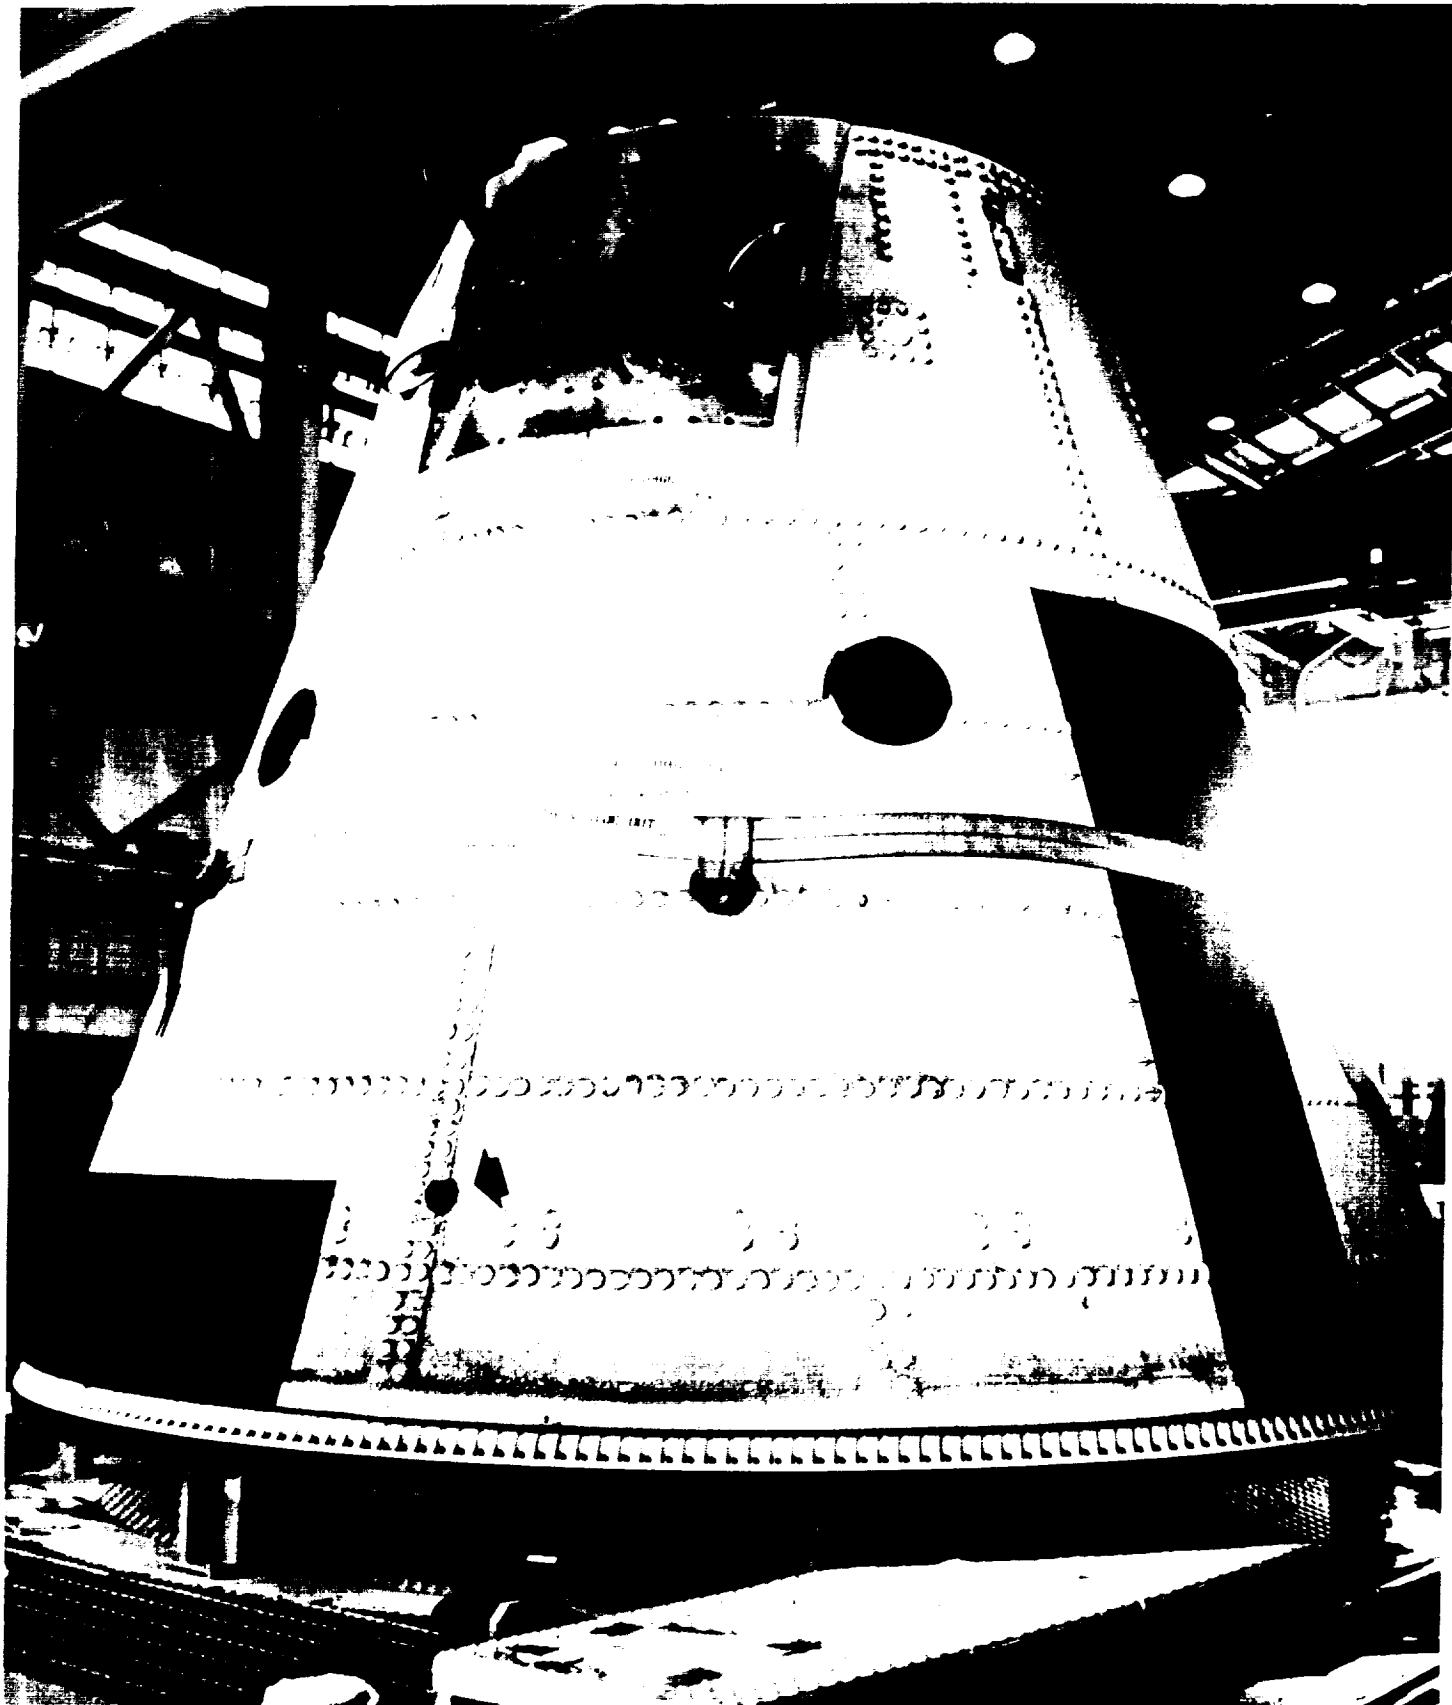
All four HDP Debris Containment System (DCS) plungers were seated. This was the third flight utilizing the optimized link. There was no sign of broaching in any of the stud holes. HDP #7 and HDP #8 EPON shim sidewall material was lost prior to water impact. MSFC will review the bonding process.

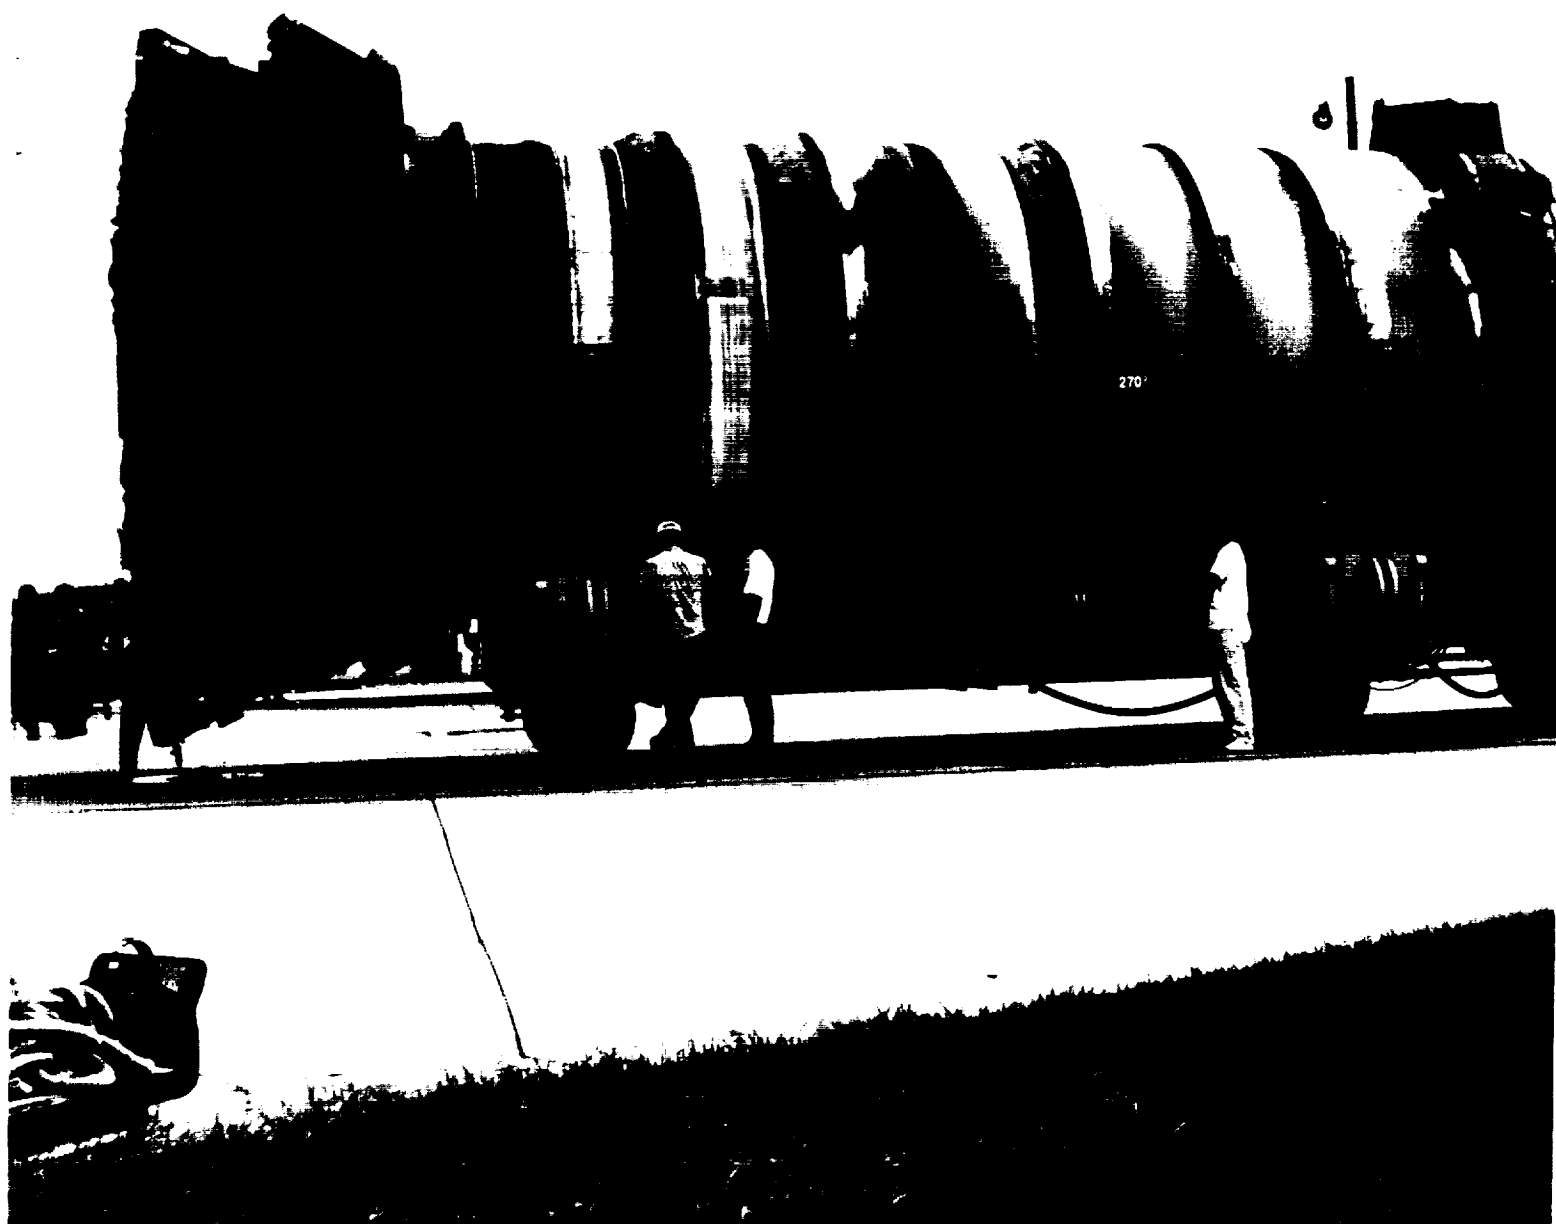
The left forward skirt exhibited no MSA-2 debonds. Minor blistering of Hypalon paint occurred forward of the ET/SRB attach point. The RSS antenna phenolic plates were intact.

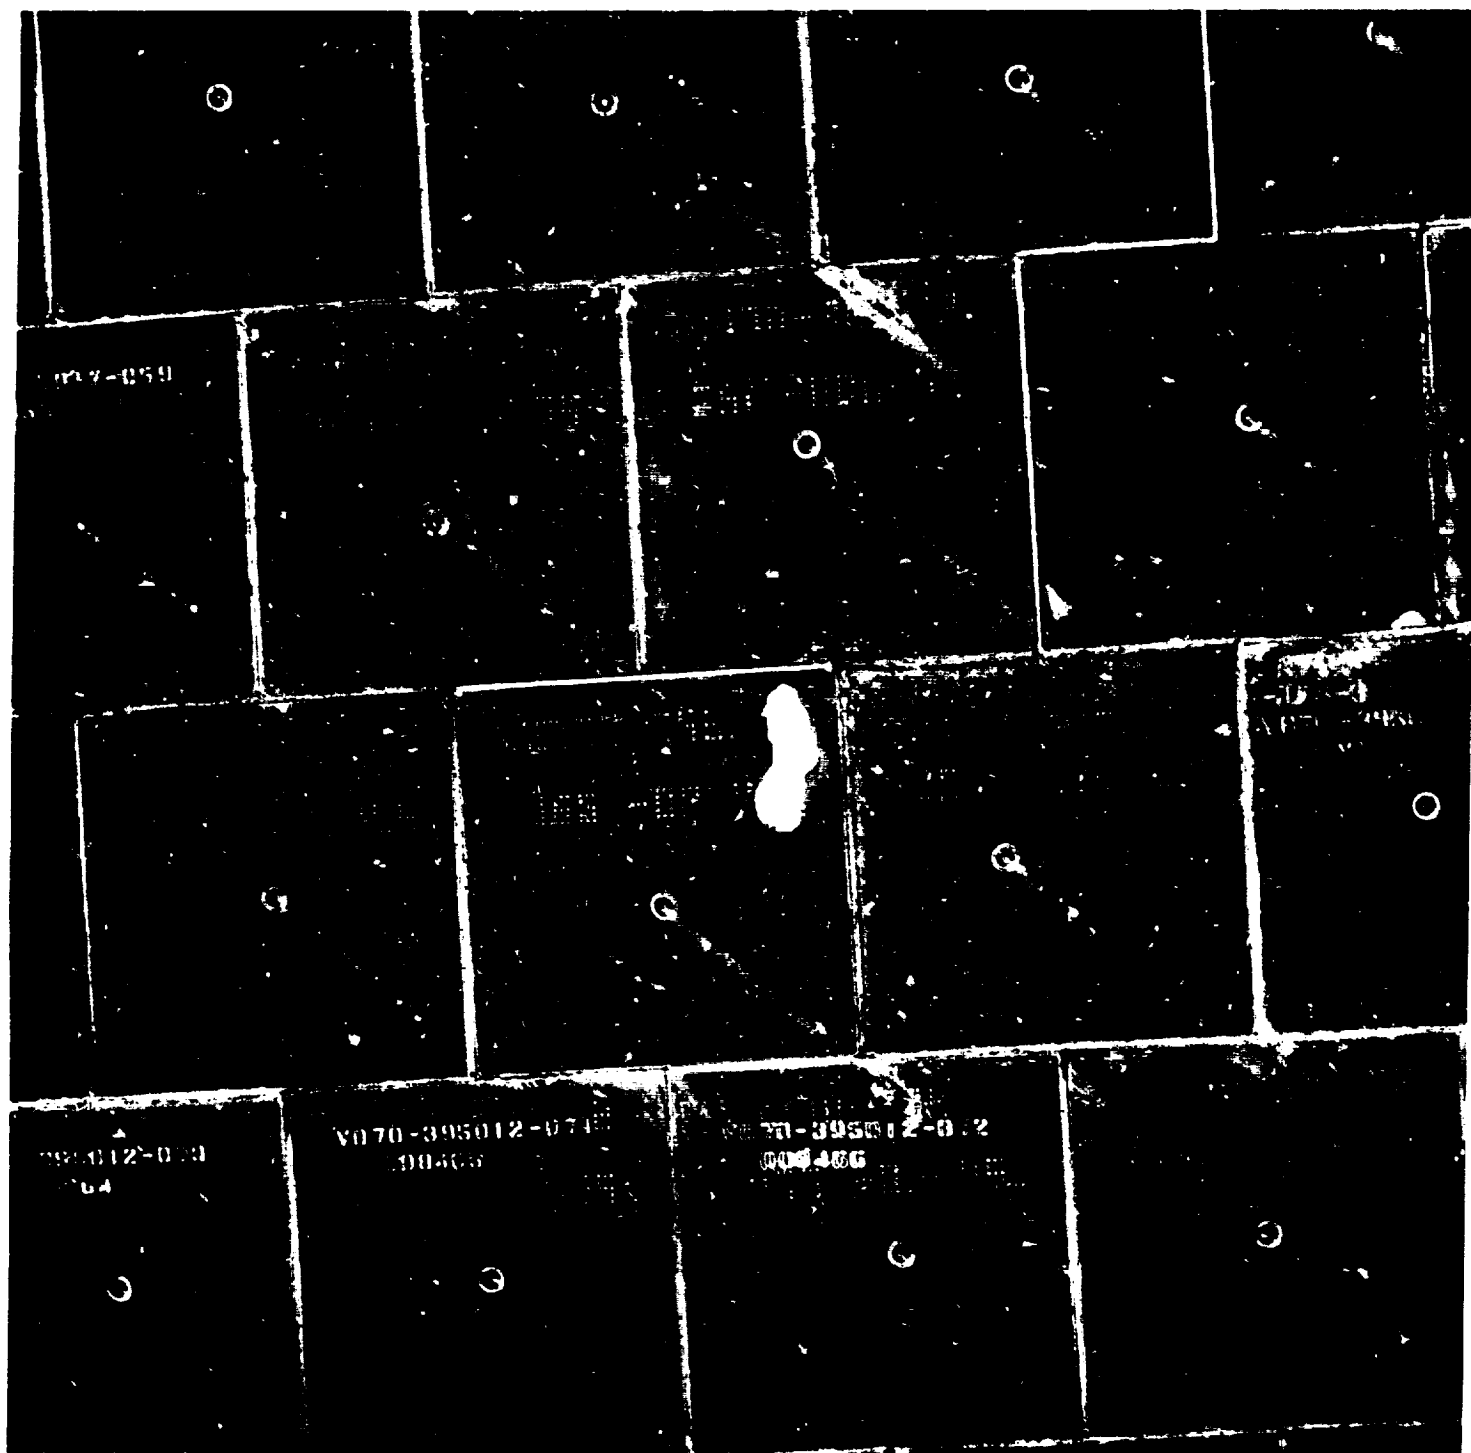
Typical tile damage on the Orbiter lower surface

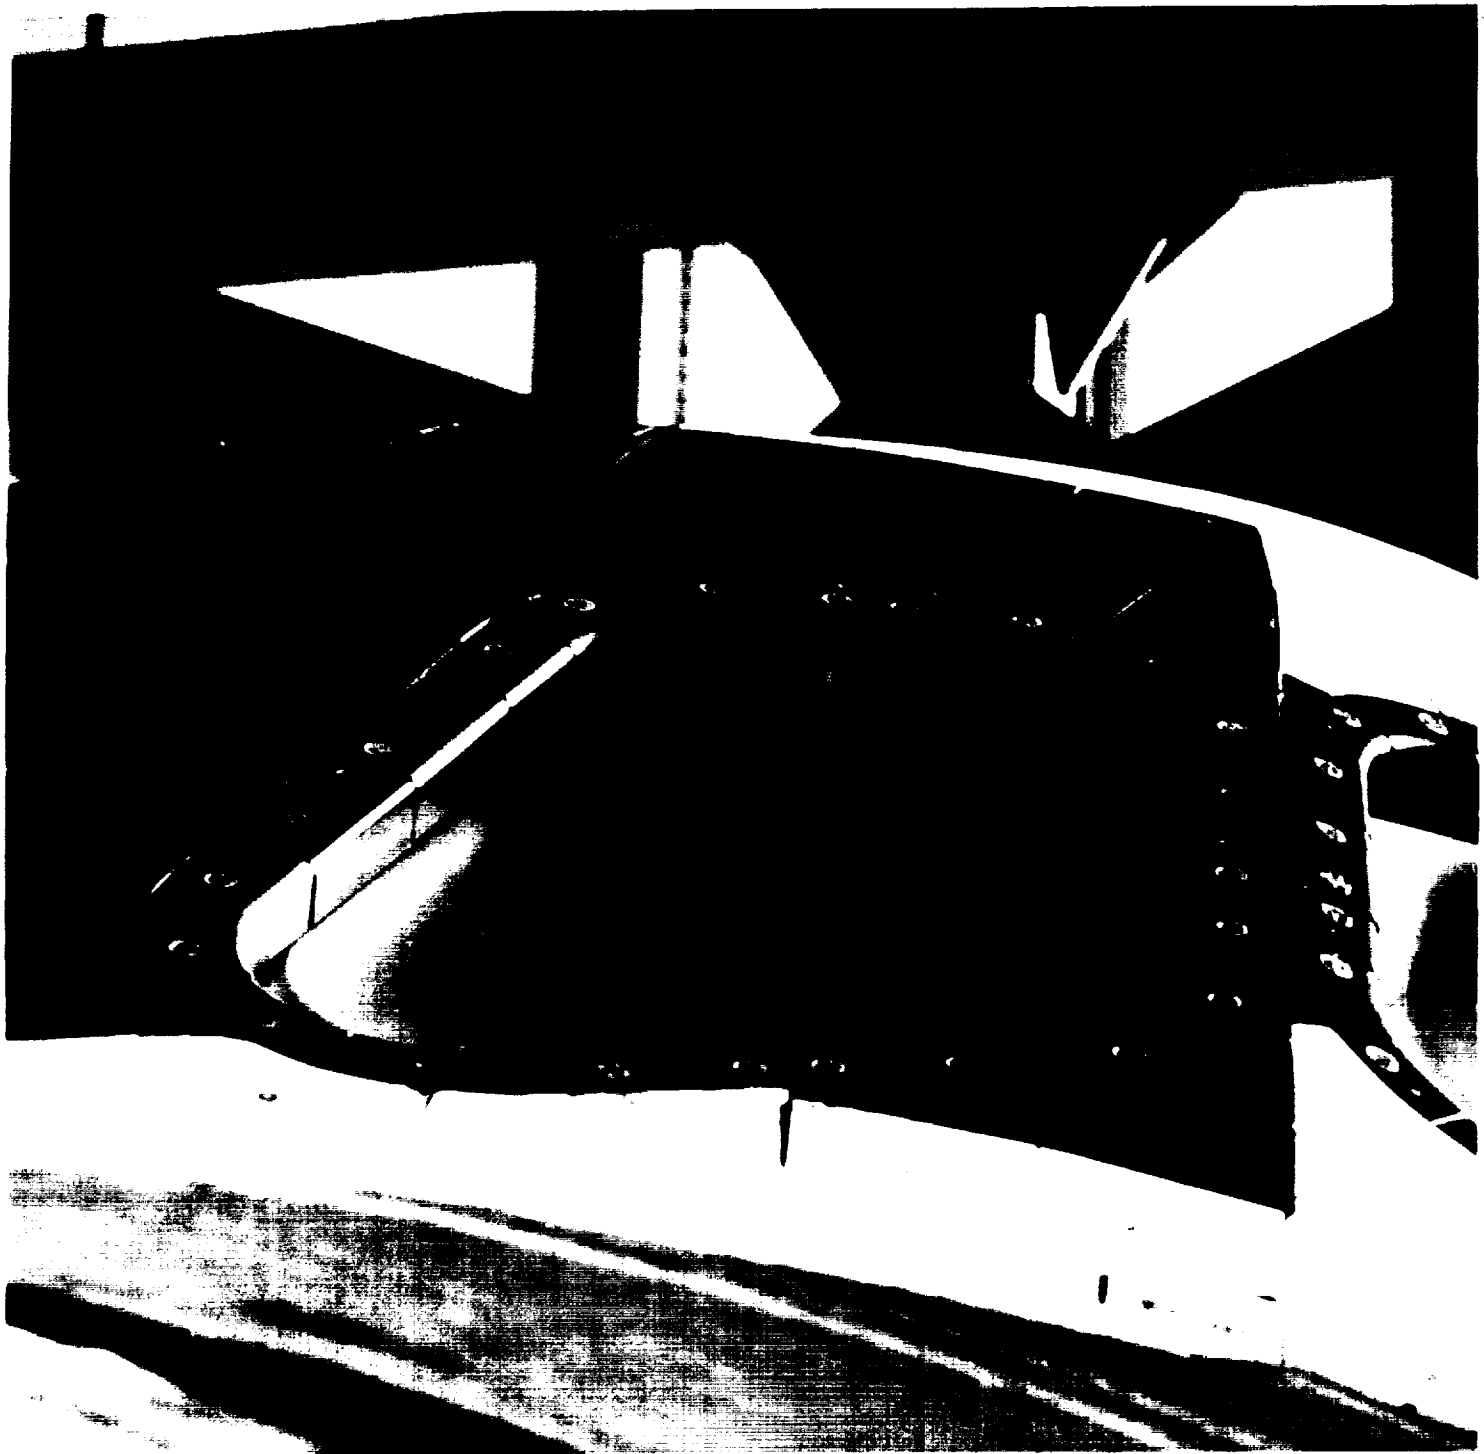
Orbiter windows #1 and #2 were lightly hazed. Window #3 exhibited moderate to heavy hazing and had numerous streaks. A greater than previously observed number of damage sites occurred on the perimeter tiles of windows #1-#6. Most of the impact sites did not exceed a depth of 1/16th inch. This damage may have been caused by the RTV used to bond paper covers to the FRCS nozzles.

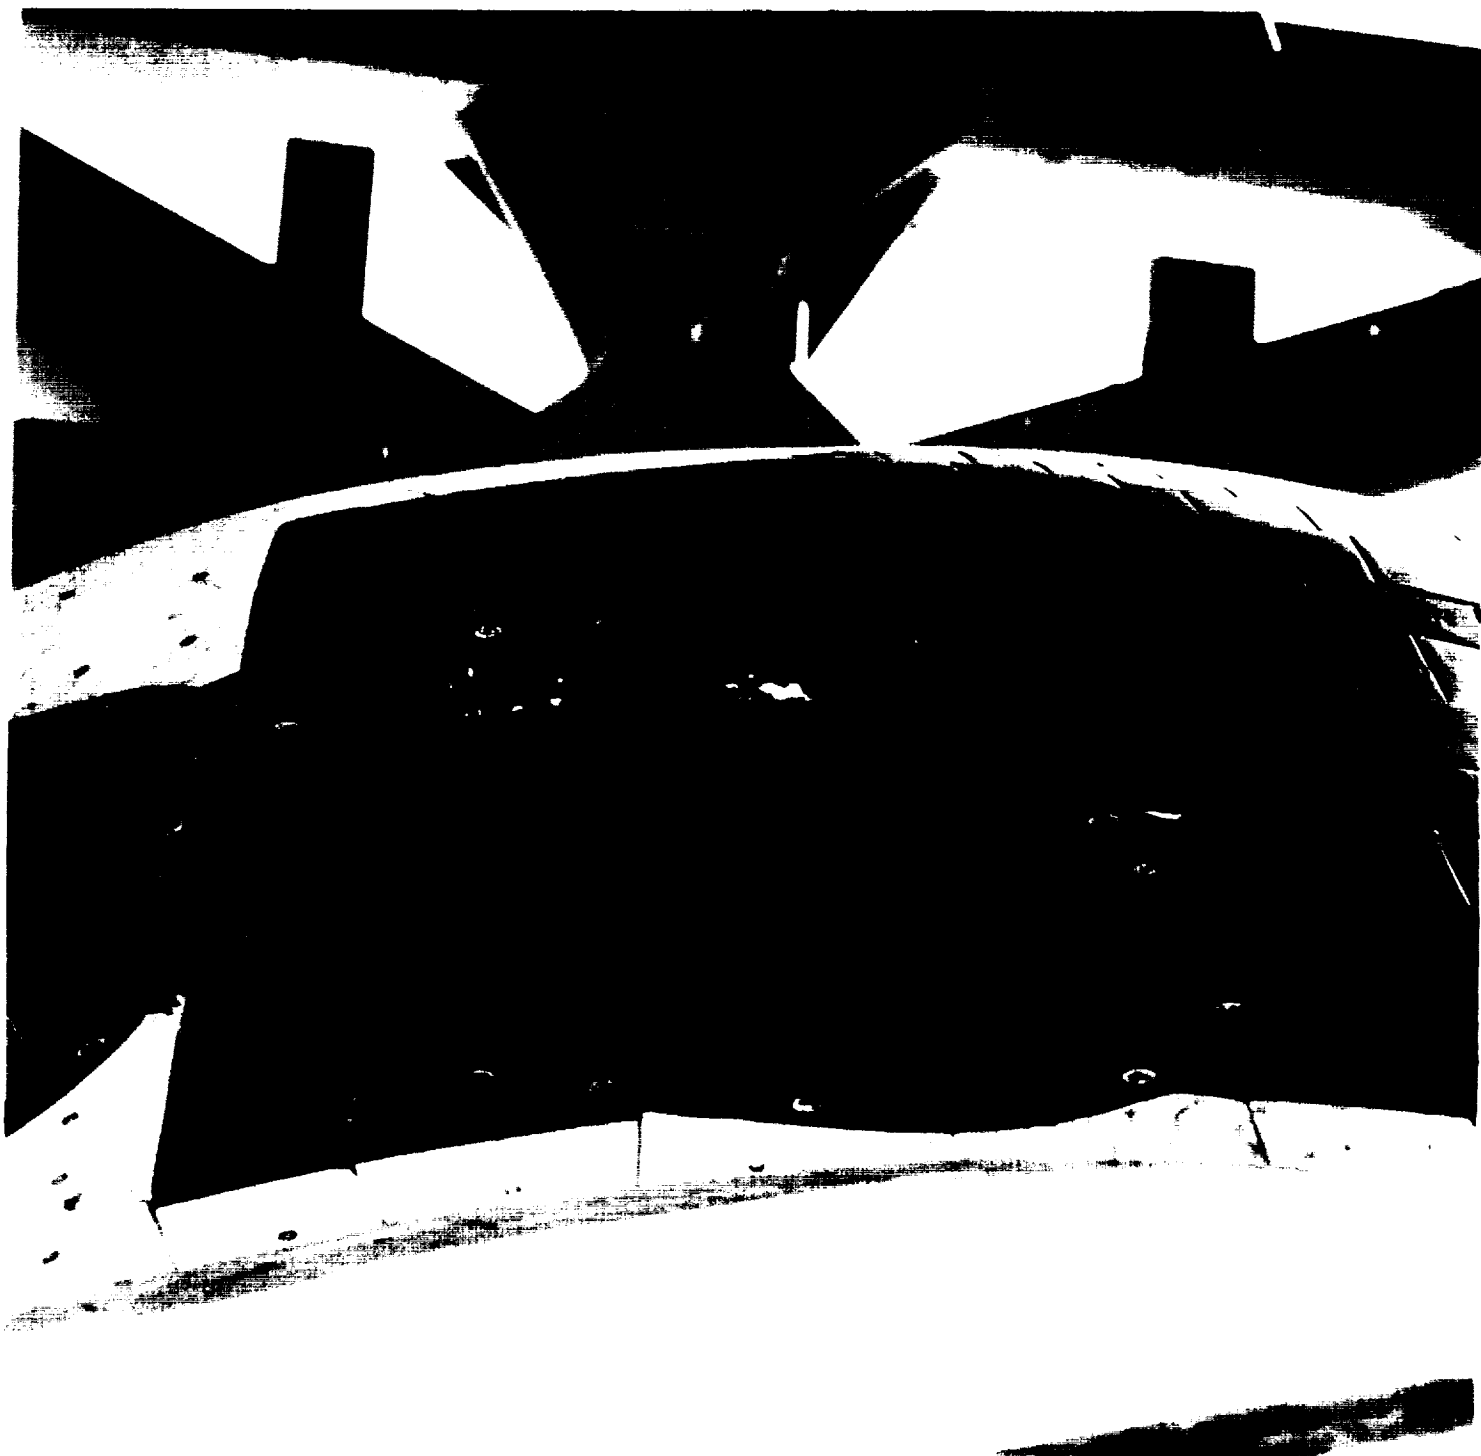
Orbiter windows #5 and #6 were lightly hazed. Window #4 exhibited moderate to heavy hazing and had numerous streaks. A greater than previously observed number of damage sites occurred on the perimeter tiles of windows #1-#6. Most of the impact sites did not exceed a depth of 1/16th inch. This damage may have been caused by the RTV used to bond paper covers to the FRCS nozzles.

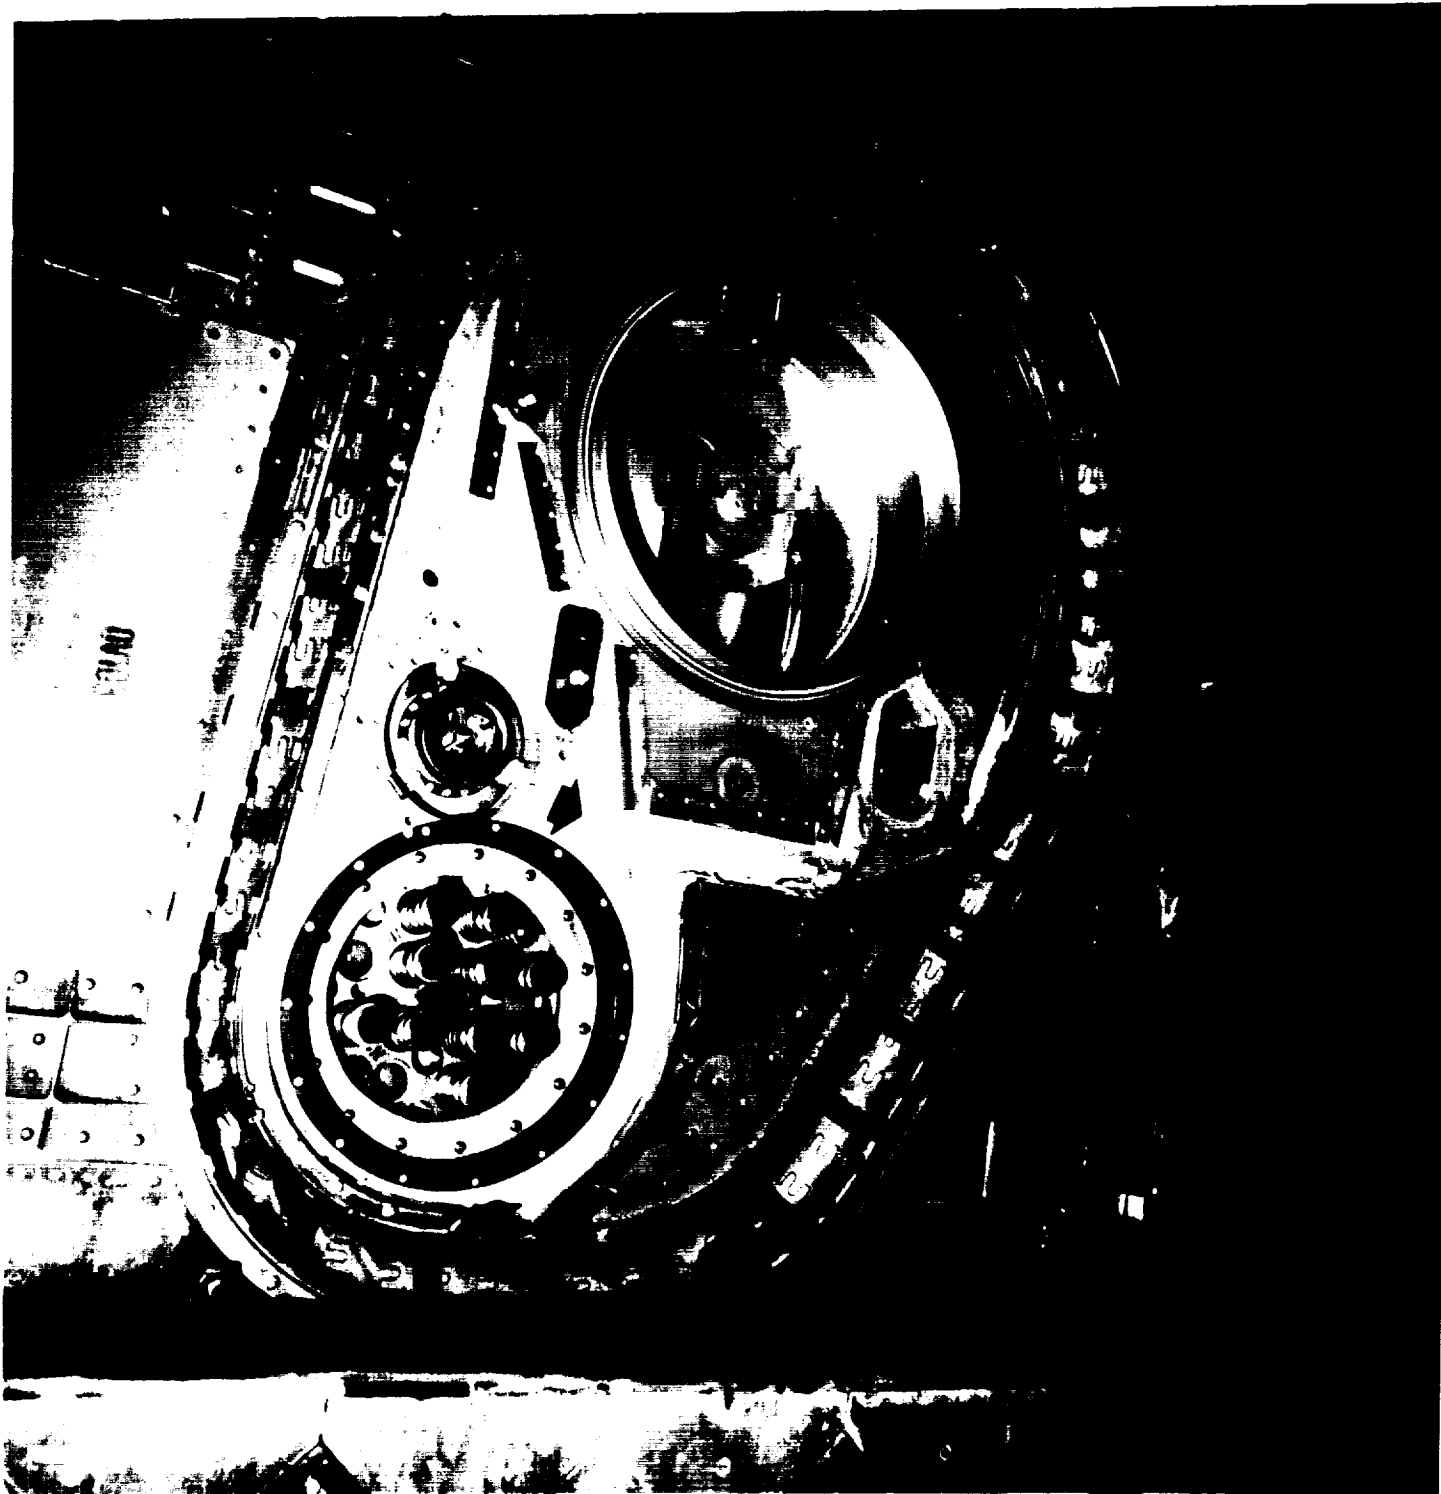
Overall view of the L02 ET/ORB umbilical. The separation ordnance device debris plunger in EO-3 was seated and appeared to have functioned properly. Wrinkling of the umbilical face plate (arrow) was probably caused by material shrinkage during cryo load and was not considered to be an anomaly.

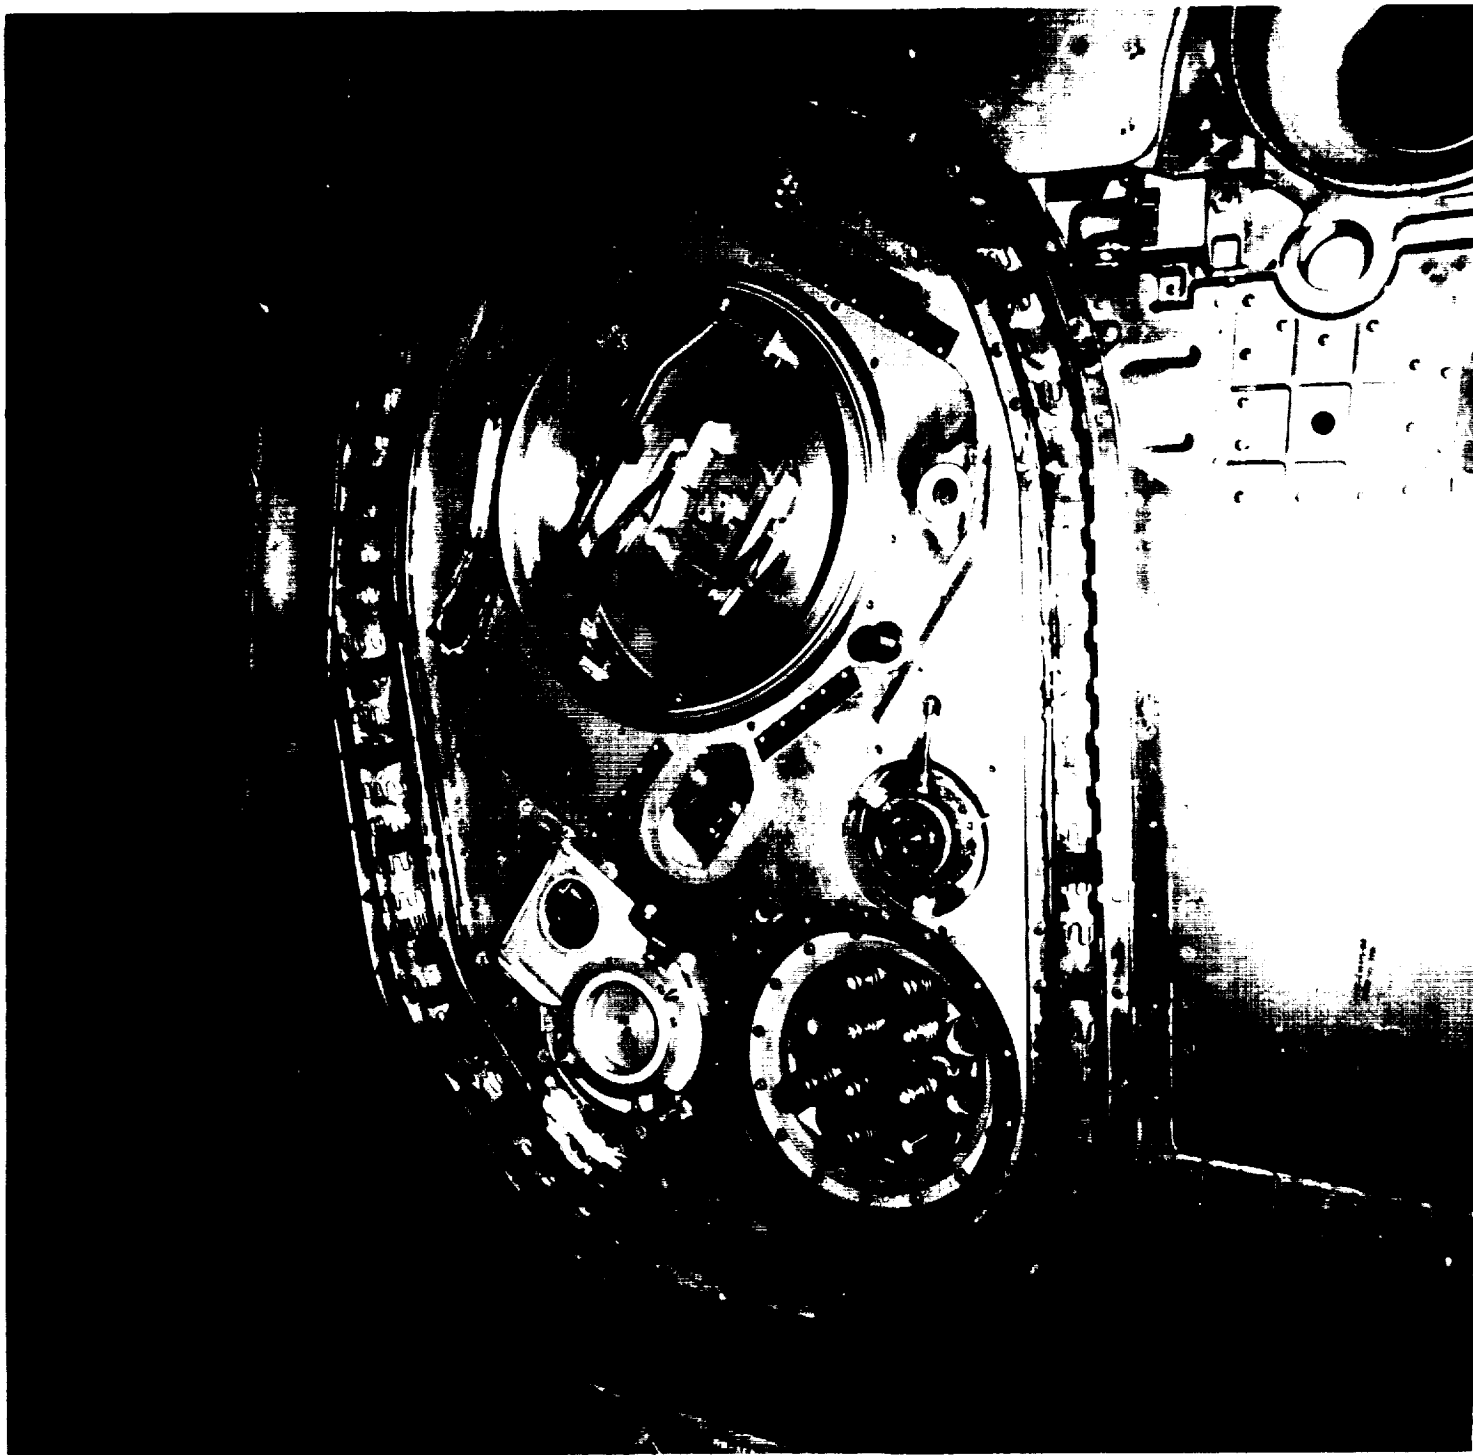
Overall view of the LH2 ET/ORB umbilical. The separation ordnance device debris plunger in EO-2 was seated and appeared to have functioned properly. There was no significant heat intrusion past the ET door thermal barrier.
